## PHASE I REPORT National Dam Inspection Program

Immel Dam

26 April 1978 (visual inspection)

Inspection Team - GAI Consultants, Inc.  
570 Beatty Road  
Monroeville, Pennsylvania 15146

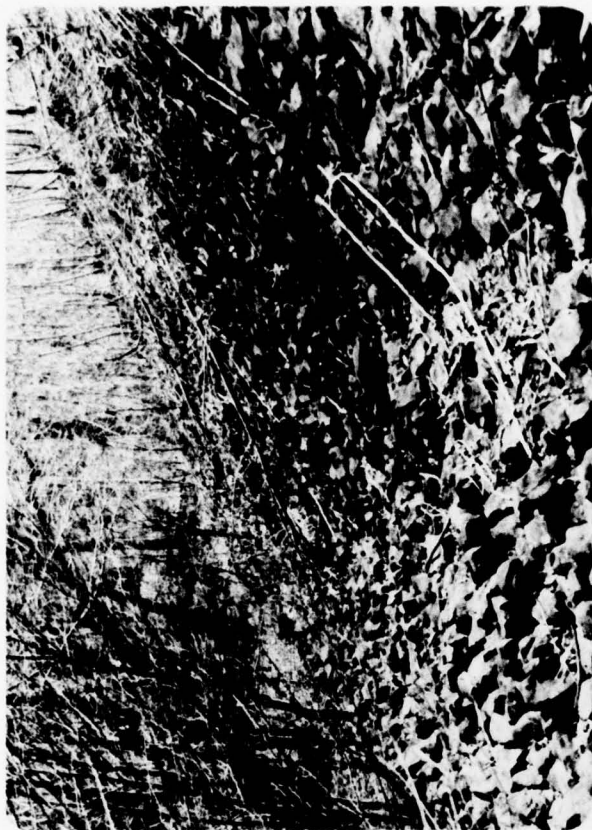
PHOTOGRAPH 20    View of the discharge end of the blow-off pipe for the Immel Reservoir. The terminal end is a 16-inch terra-cotta pipe. However, this is said to be an extension of the original blow-off pipe which is reported to be a 16-inch cast iron pipe. According to water authority personnel, they were currently trying to maintain the present water level within Immel Reservoir.
